Belhaven Parking Study Results and Recommendations

The Town of Belhaven
Lynn Davis, Town Manager
252-943-3055, ldavis@townofbelhaven.com
www.TownofBelhaven.com

November 5, 2020

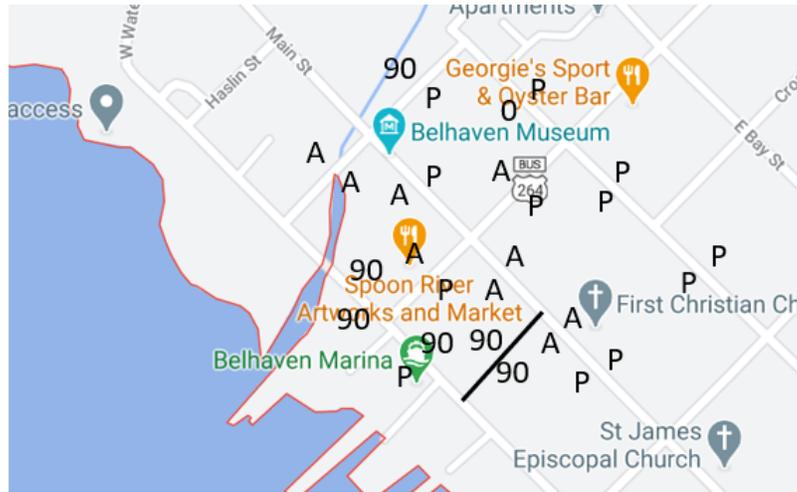
Figure 1. Study scope.

The spatial scope of the study was limited to on-street parking in the downtown area around the central intersection of Main and Pamlico Streets, where Business US-264 turns from eastward on Main to northward on Pamlico. NCDOT (on Business US-264) and the Town (on other nearby streets) have provided a good deal of on-street parking which was the focus of this study. Figure 1 shows the area of the study, which included a six-block area bounded by Pungo, Allen, Water, and Edward Streets. Edward Street was not included within the scope of the study, as it has on-street parking but the generators are mostly the churches on Sunday mornings. Figure 1 also shows that some of that on-street parking is parallel, some is at an angle, and some is at 90 degrees. There appears to be a good deal of off-street parking or vacant, accessible, and publicly-owned lots that could be used for parking around the downtown area as well.

Inventory
 P = parallel
 A = angle
 90 = 90-degree
 0 = none

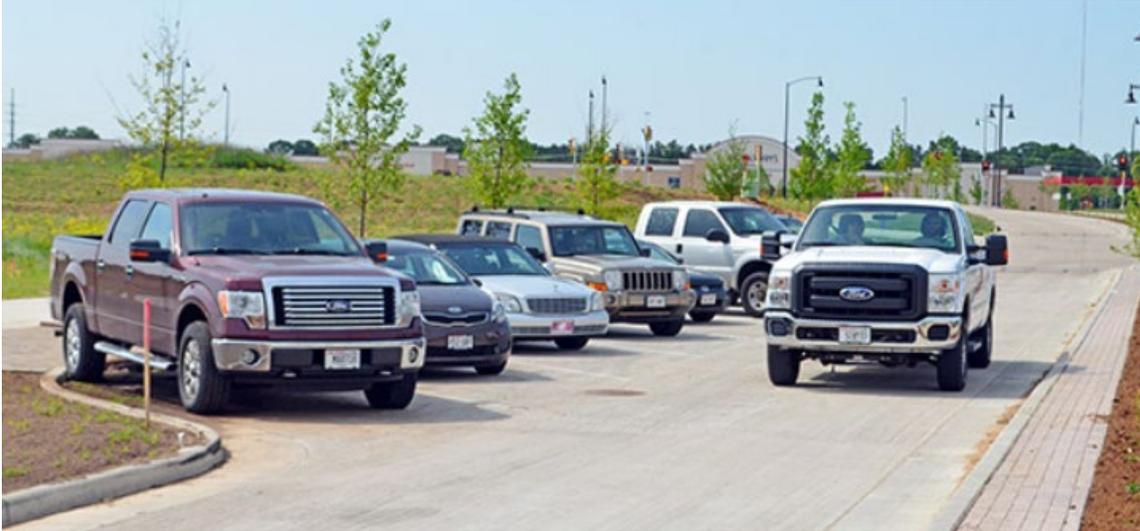
Figure 3. Relatively new back-in angle parking in Wisconsin (from <https://www.ayresassociates.com/back-angle-parking-easier-safer/>).

- The Town should repaint lines where they are faded, especially for angle spaces.
- The Town should consider converting angle parking to “back-in” style on its streets, and working with Division 2 to make the conversion on Main Street west of Pamlico as well. Back-in angle parking has been slowly gaining ground throughout the US in the past thirty years. It has several benefits, especially in safety, as it eliminates many of the conflicts we saw during data collection between vehicles backing out of an angle parking space and oncoming through vehicle. Figure 3 shows a fairly recent example in Wisconsin. Some positive references to back-in angle parking from the Pedestrian and Bicycle Information Center maintained at UNC for the Federal Highway Administration are:
